NBSIR 76-1044 (R)

Selected Problems Related to the Storage of Mobile Homes for Use as Disaster Housing

April 1976

Final Report

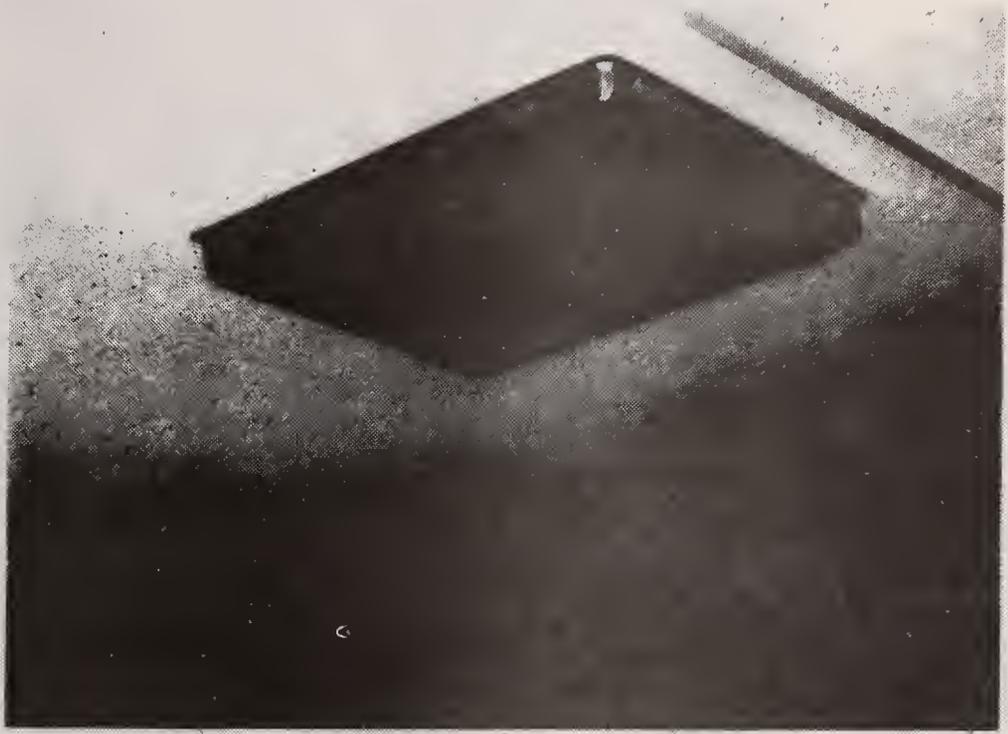
3.2.1 Discussion. Stains on ceiling material resulting from rain leaks through the roof were visible in varying magnitudes in 27% of the refurbished units inspected. Damage generally consisted of localized discoloration of the ceiling panels along the perimeter of the unit (figure 2). Very few rain leak stains were observed in the area of penetrations through the roof for vent pipes, exhaust fans, etc. (figure 3). These could become a more prominent source of leaks as the sealing agent used to seal the penetration against moisture loses its integrity due to aging which can change its physical properties or movement of the sealed joint due to transportation and site set-up (figure 4).

Figure 3 Water Damage to Ceiling Due to Rain Leak at Stack Penetration Through Roof

- C. New rain leak stains will not be passed off as existing stains that were not overcoated.
2. All rain leaks through the roof found during refurbishment or routine periodic inspections should be repaired by applying a mastic sealing material (fiber reinforced aluminized asphalt emulsion commonly used by the mobile home industry) to the joints in selected parts of the roof surface. The following procedure is recommended:

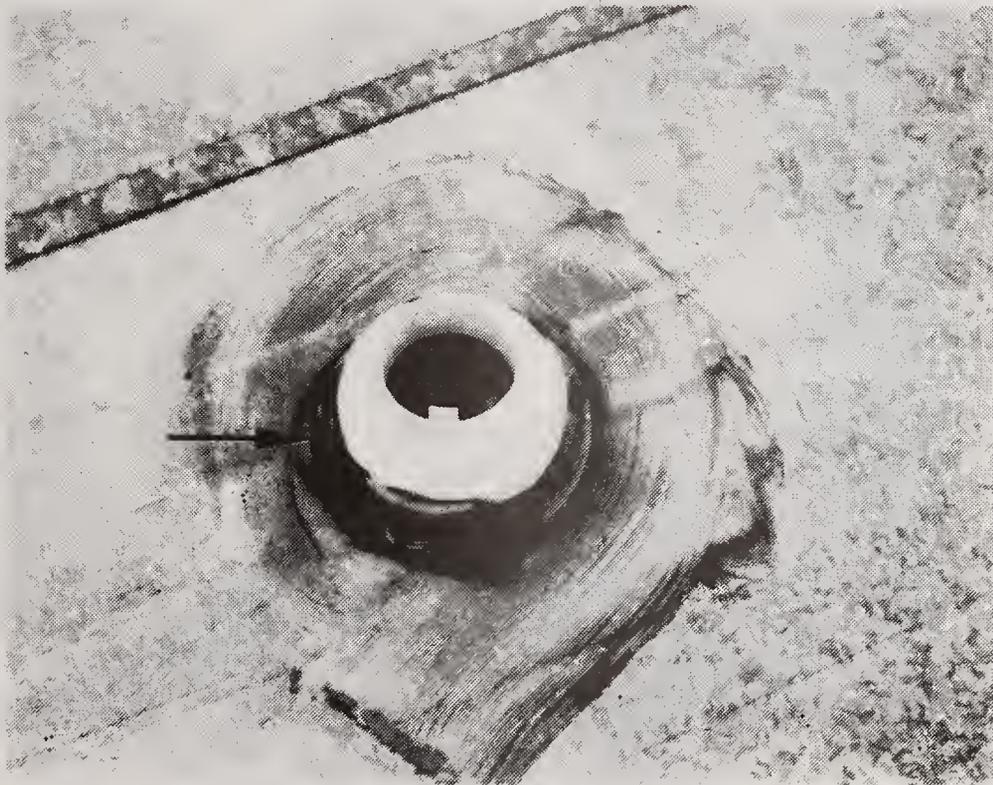
Figure 4 Plumbing Vent Penetration Through Roof - Failure of Sealant at Flashing

- A. After a rain leak is identified, mastic sealing material should be applied to the perimeter joint, transverse seams, and roof penetrations on both sides of the leak. The sealing should extend at least two transverse seams on each side of the leak (see figure 10). This recommendation is a judgment made without a basis of research data.

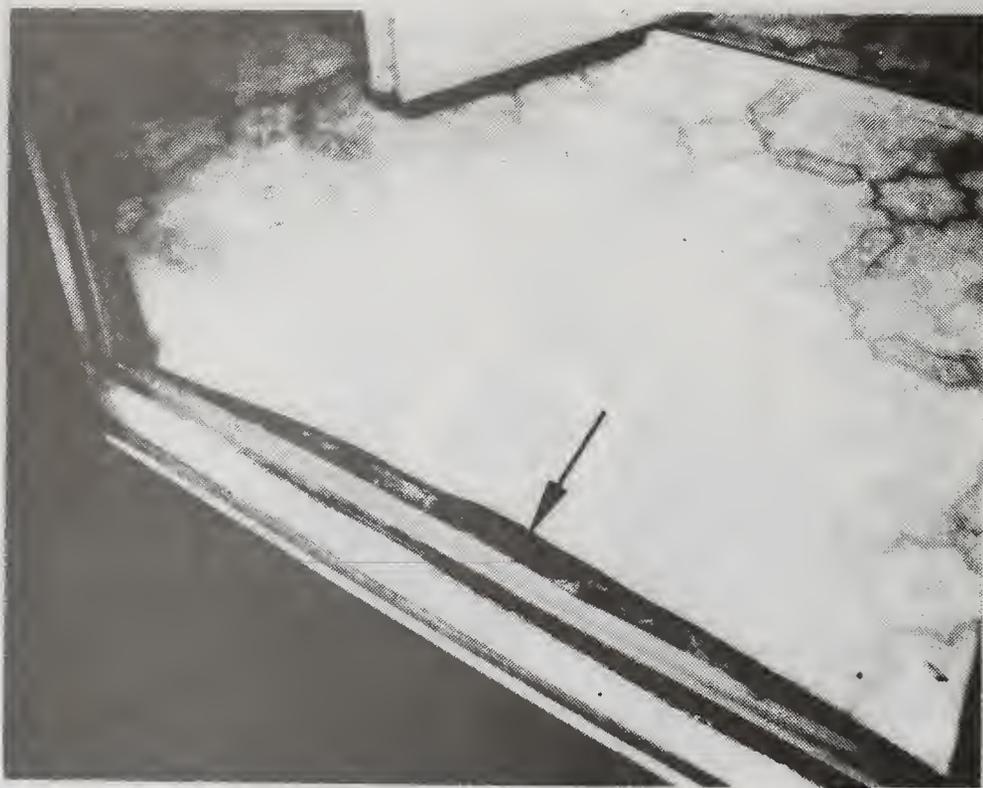
Rain leaks, through poorly fitting or deteriorating exterior doors, resulted in damage to the interior of some units. Several incidences of floor deterioration near the doors were attributed to this condition (figures 6 and 7). Doors with exterior vinyl coverings appear to be particularly susceptible to water penetration with the subsequent deterioration of the door and entry of water into the mobile home (figures 8 and 9). Eight doors with vinyl coverings were observed to be deteriorated.

Figure 6 Rain Leak Damage to Flooring at Exterior Door

4. All entrance doors should be inspected for deterioration at least once a year. Doors with vinyl skins found to be soft and wrinkled should be replaced in order to prevent floor damage due to the entrance of rain water. Doors of other types of construction (wood, steel, aluminum, etc.) which are deteriorated to the point where exterior moisture can enter the mobile home, should also be replaced.

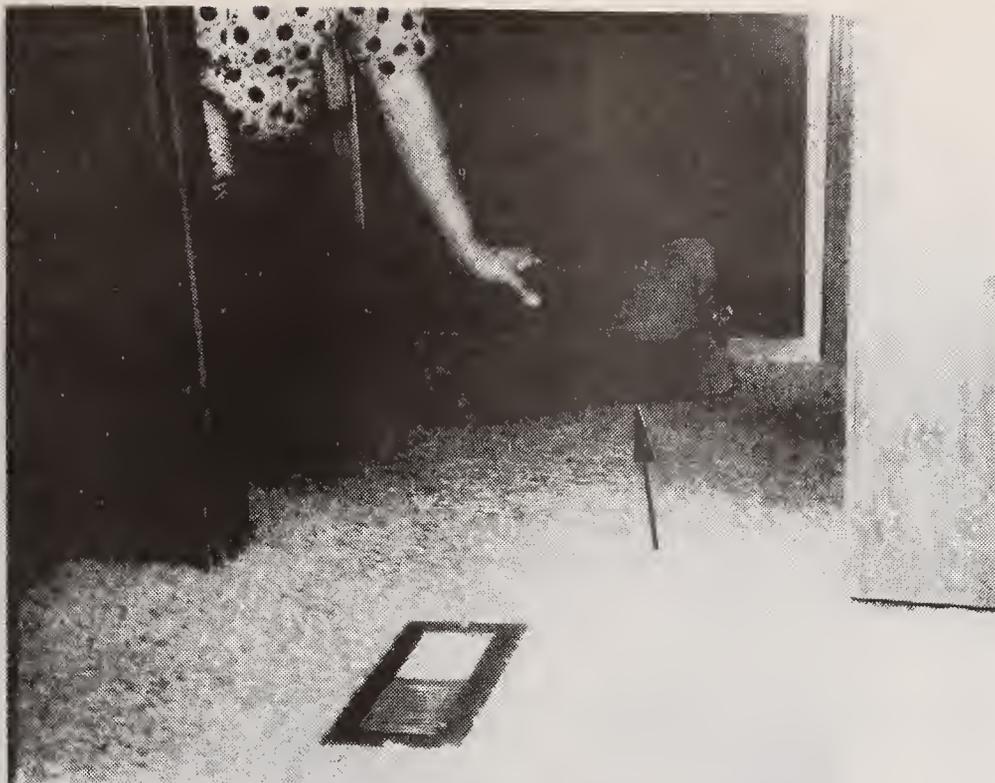
Figure 7 Buckled Floor Decking Due to Rain Leak at Exterior Door

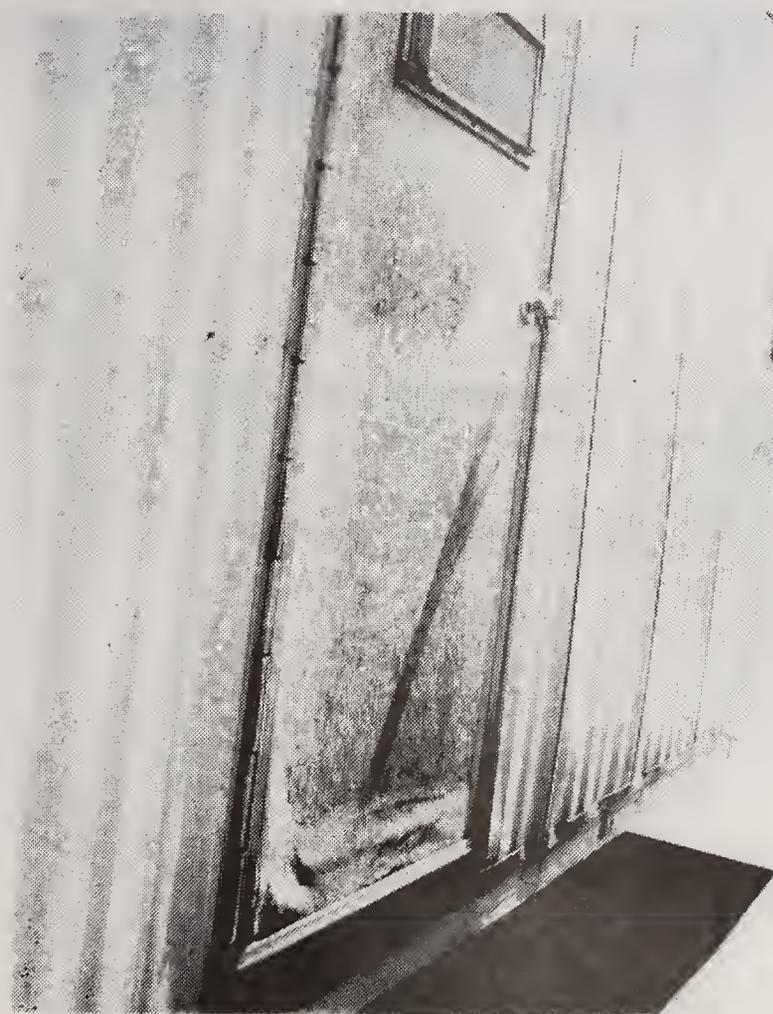
Figure 8 Deteriorated Vinyl Covered Exterior Door

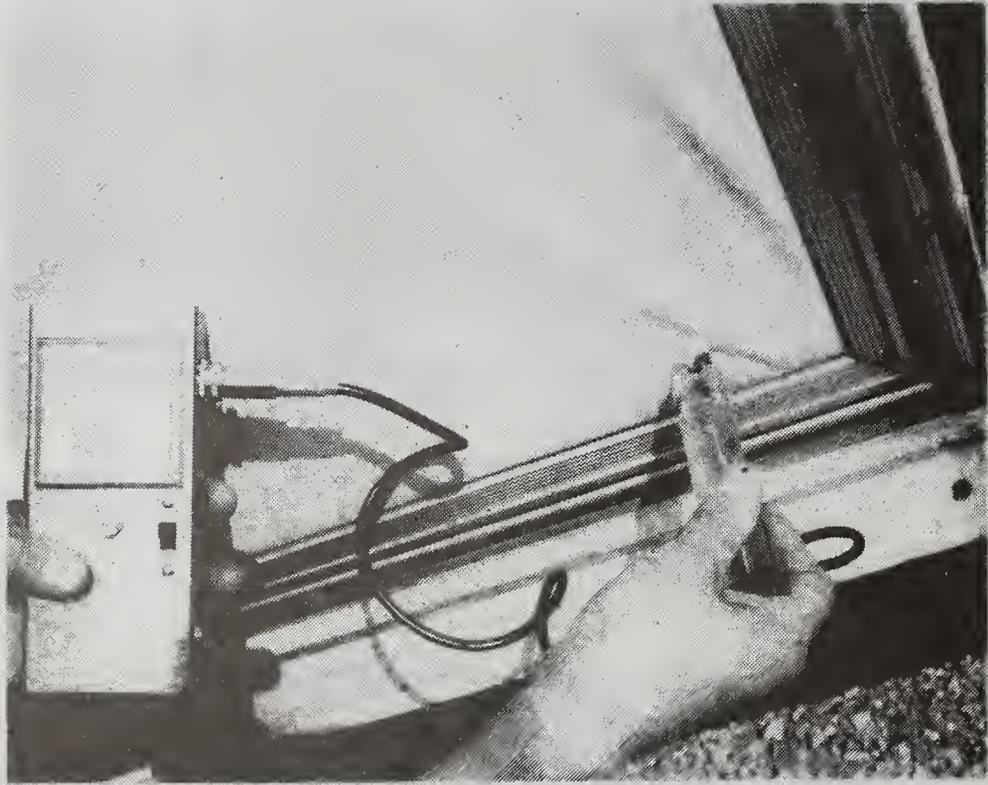
Figure 9 Measuring Moisture Content of Deteriorated Vinyl Covered Exterior Door

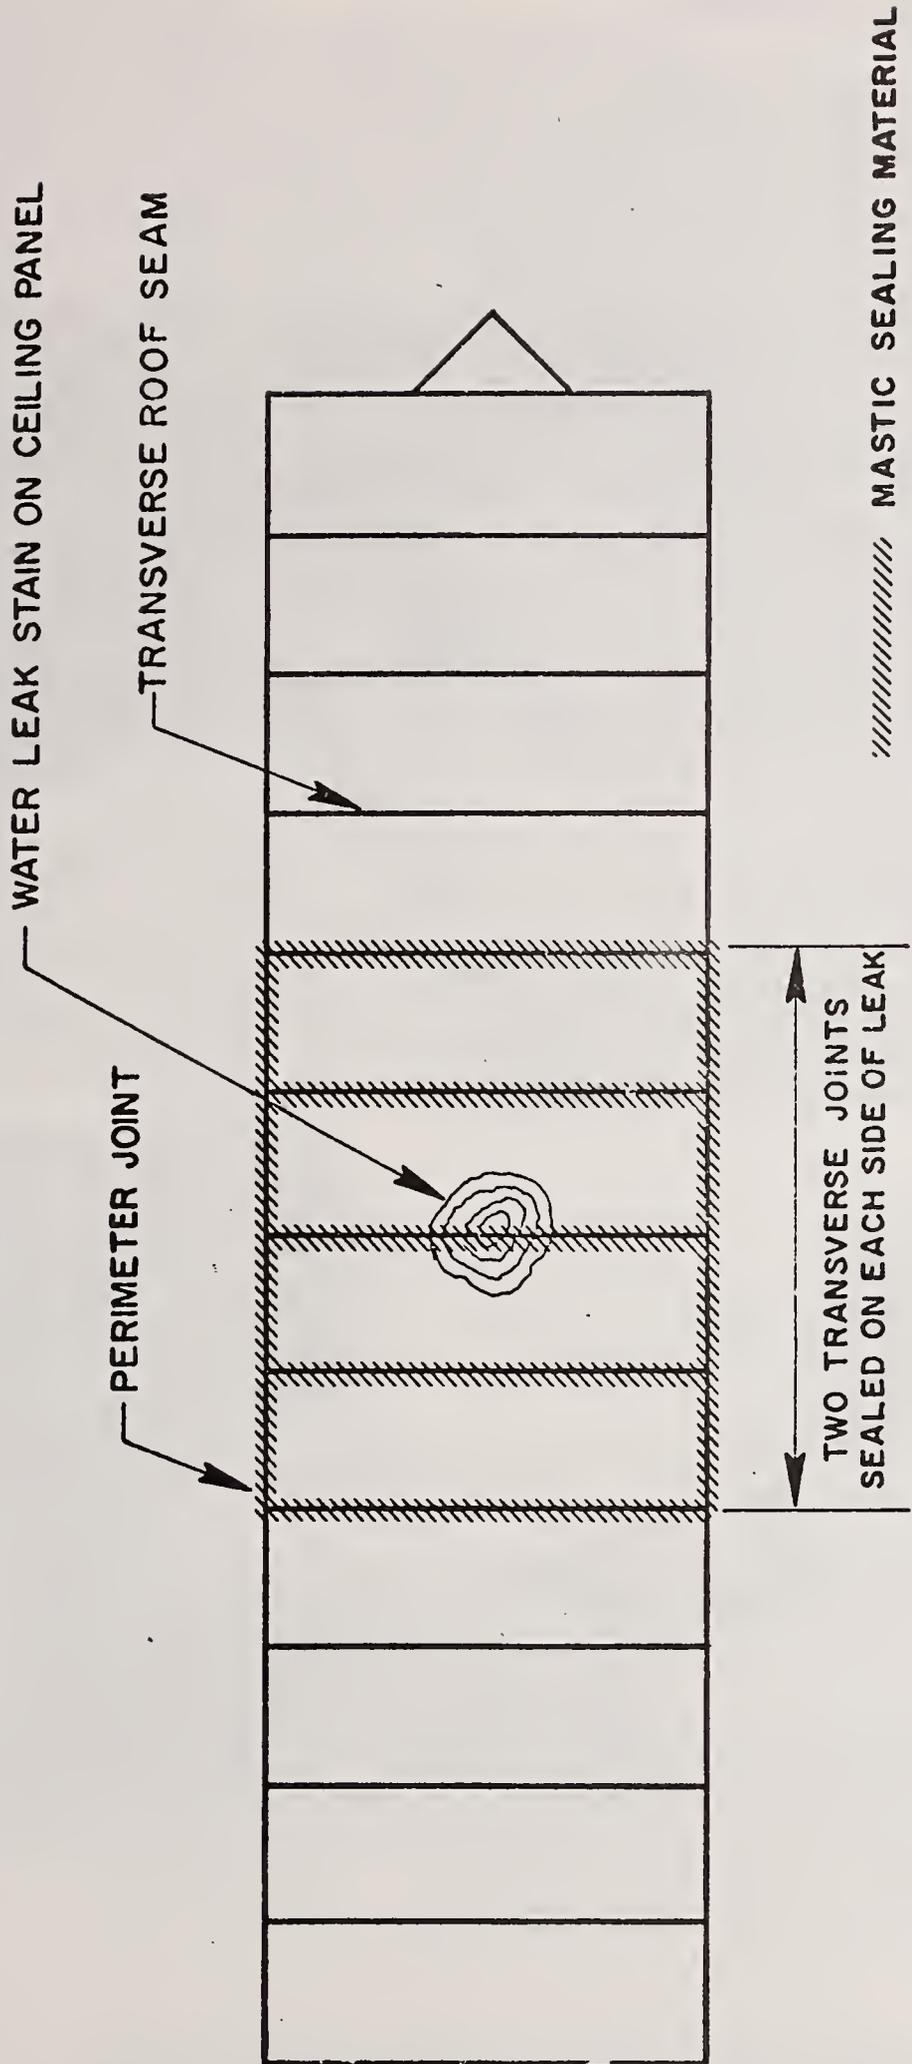
Figure 10. Plan View of Roof Membrane - Application of Sealing Material to Stop Rain Leak

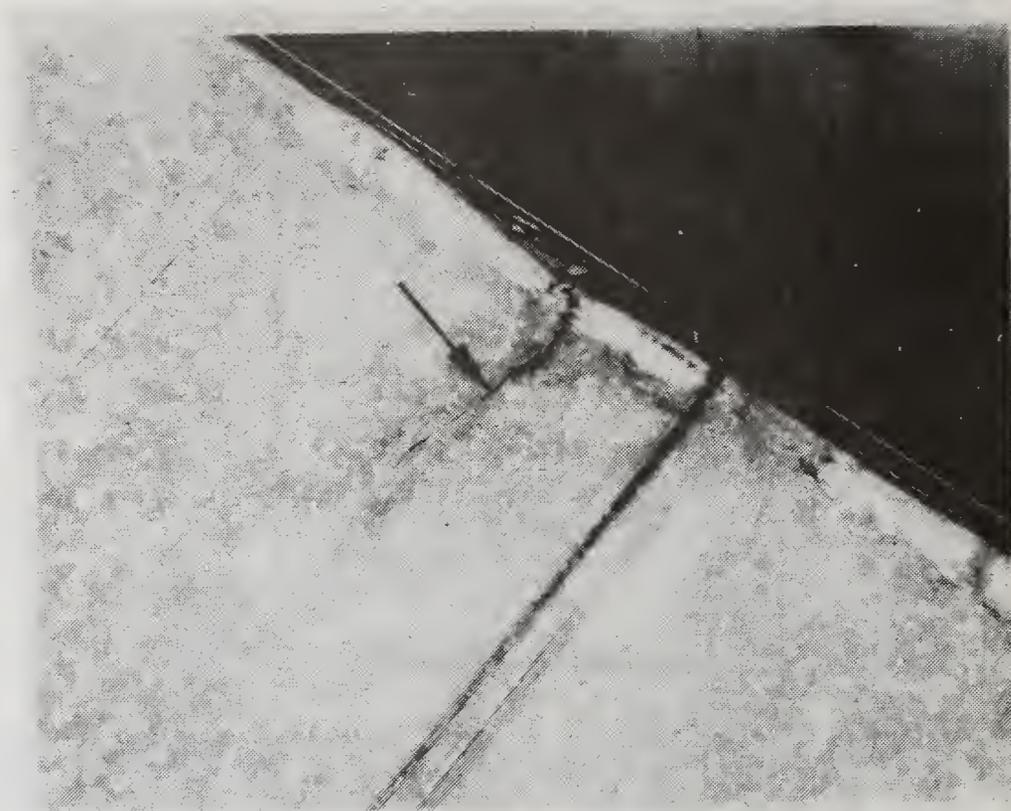
A few instances (0.7%) of ruptured metal roof covering were also observed. The concept of overcoating water leak stains on the ceiling panel with paint while repairing the source of the leak on the roof allows an inspector to distinguish new water stains from old stains. Figure 5 is an example of a continuing rain leak at an overcoated area. Generally, this overcoating procedure was not followed by the various SSC's as only three of the 40 units with water stains were overcoated. Because of this inconsistency, it is possible that some of the stains found in this study were not overcoated when the rain leak sources were repaired.

Figure 11 Crack in Roof Membrane

3. Ruptures in the metal roof covering (figure 11) should be repaired. An accepted method of repair would be to imbed a piece of fiberglass tape or fiberglass skrim cloth into the mastic sealing material. The tape or skrim material should cover the ruptured roofing membrane and extend at least 6 inches in all directions beyond the damaged area.

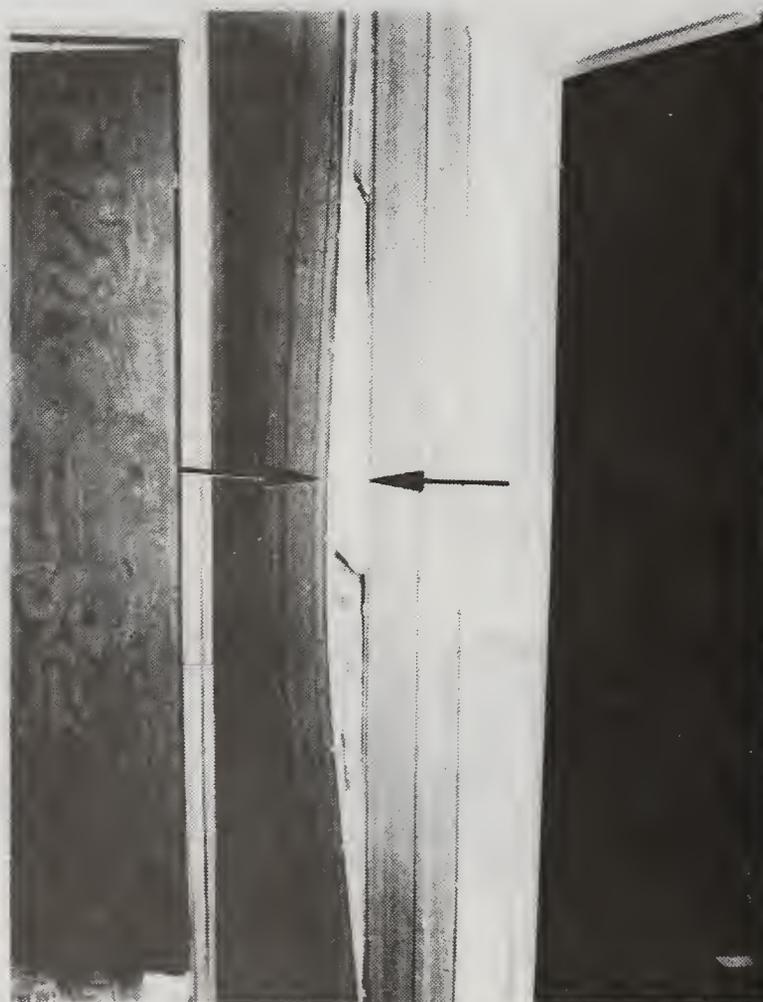
Deterioration of mobile home components due to rain leaks can be quite severe if not promptly repaired (figures 14 and 15). It is believed that prompt repair of the leak combined with the natural ventilation characteristics of the unit should have a drying effect thus preventing further damage.

Figure 15 Buckled Interior Paneling Due to Water Penetration and Moisture Expansion

2. Sources of rain leaks should be promptly repaired to prevent further deterioration of mobile home components. The air infiltration characteristics of the sealed mobile home should be sufficient to dry out the unit if this external source of moisture is removed.

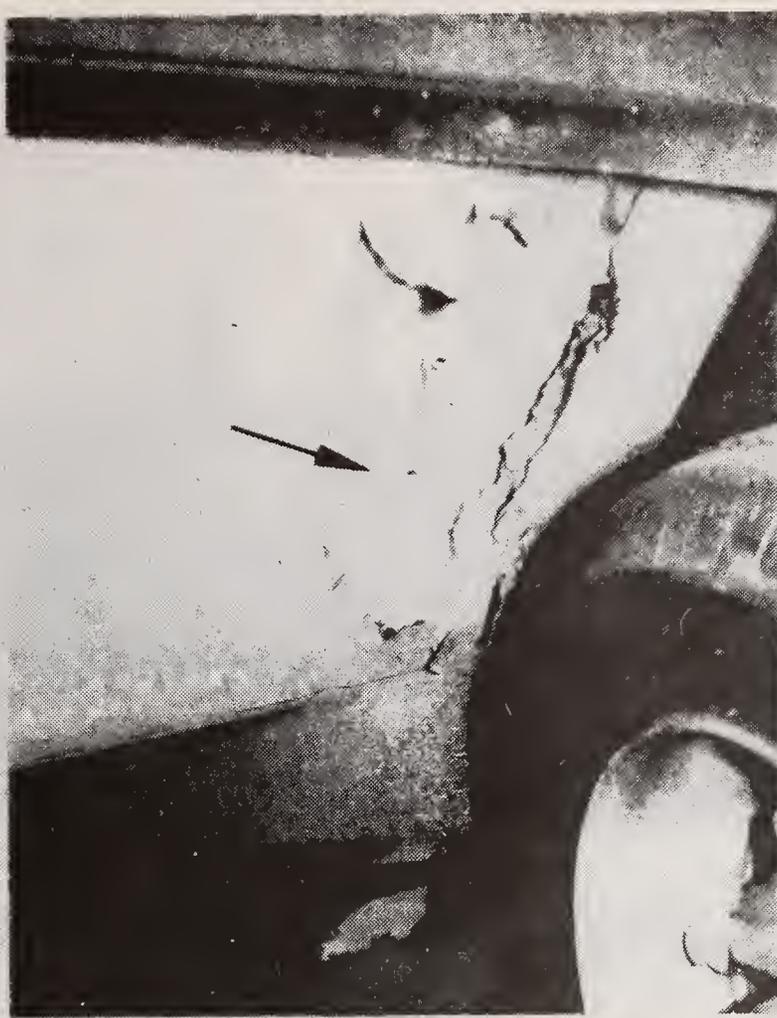
Figure 20 Bottomboard and Insulation Erosion Above Wheel

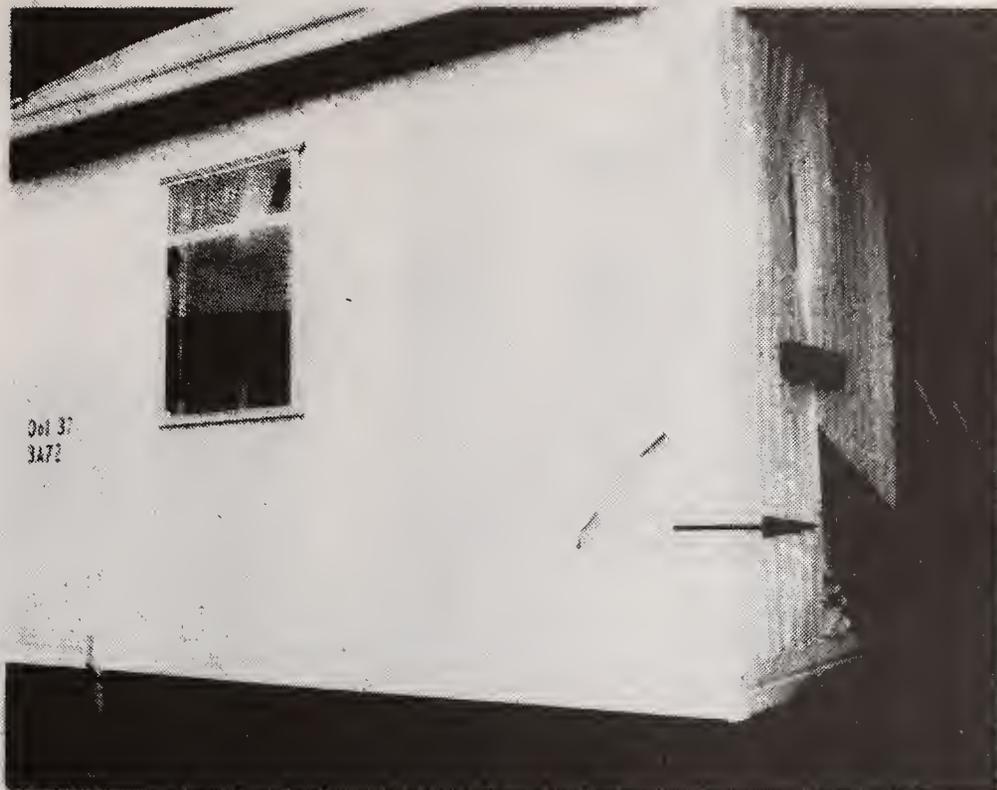
3.5.1 Discussion. Transit damages observed during storage center visits included: loose, dented, torn and missing metal wall panels - 36.5% (figures 24 and 25); roof overhang damage (figure 26); torn bottomboards - 25% (figure 19); excessive "I" beam deflections - 28.4% (figure 27); bent "A" frames - 3.4% (figure 28); and cracked or broken windows - 36.5% (figure 29). The relationship between the degree of transit damage and the speed at which the mobile home is transported is suspected but could not be verified. Inspection of transit damaged units indicated that damage was either very minor or of major proportions. There is no effective way to completely safeguard the mobile home structure against the effects of driver carelessness and bad driving habits (including excessive speed). Control of the toter driver is the only alternative. This may be accomplished by assessment for damages to the unit, and/or a suspension of the driver and/or his company from further transport of mobile homes. It was reported that the toter driver and/or his employer are responsible for damages incurred during transit as per the contractual agreement.

Figure 24 Transport Damage - Siding Peeled Back

1. The metal strapping, secured to the exterior surface of the mobile home walls appears to be quite effective in reducing metal skin damage during transit. The refurbishment procedure should include the addition of strapping to those units that do not have such strapping.

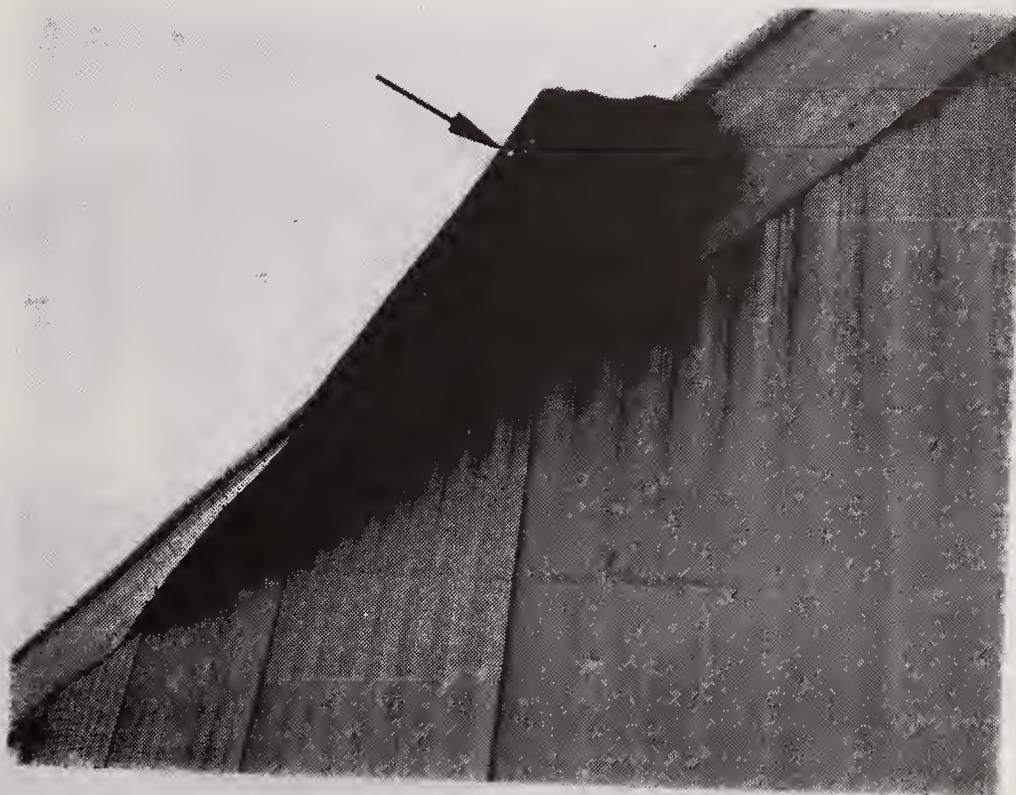
Figure 25 Transport Damage - Loose Attachment of Top Trim

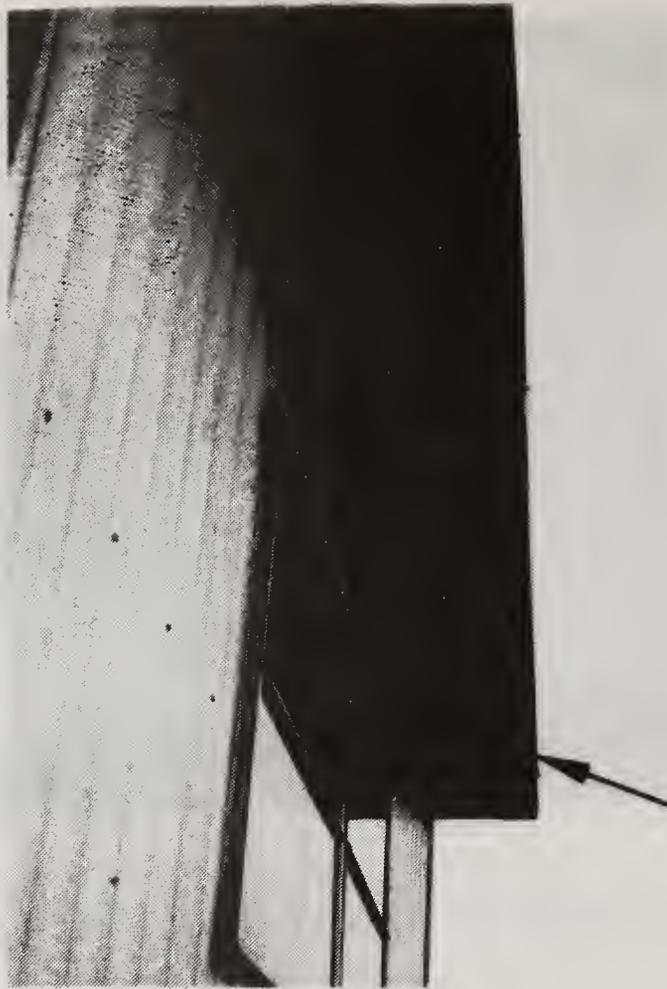
Figure 26 Transport Damage at Front Overhang

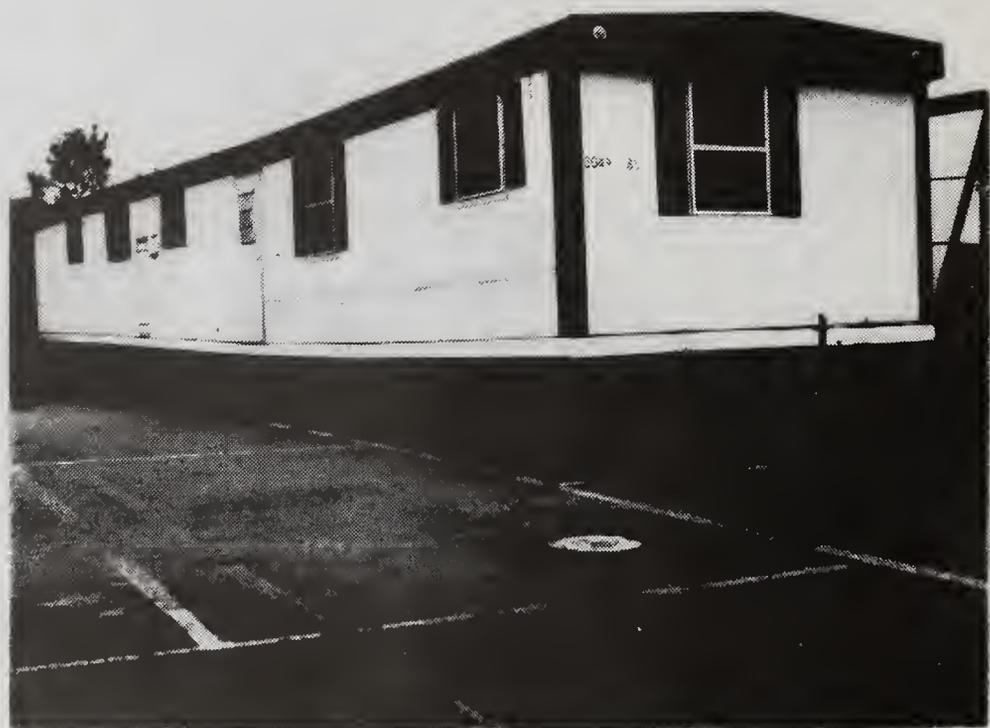
Figure 27 Transport Damage - Excessively Deflected Longitudinal Structural Members (Broken Back)

- A. Select a number of recambered units at a particular storage center.
- B. Thoroughly inspect these units and measure any beam deflection existing prior to dispatching the unit to a disaster area.
- C. Thoroughly inspect the units and measure beam deflections upon arrival at the disaster area and note any changes.
- D. Analyze damages to determine their relationship to the recambered beams.
- E. Written instructions for deflection measurement should be provided to insure consistency of data.

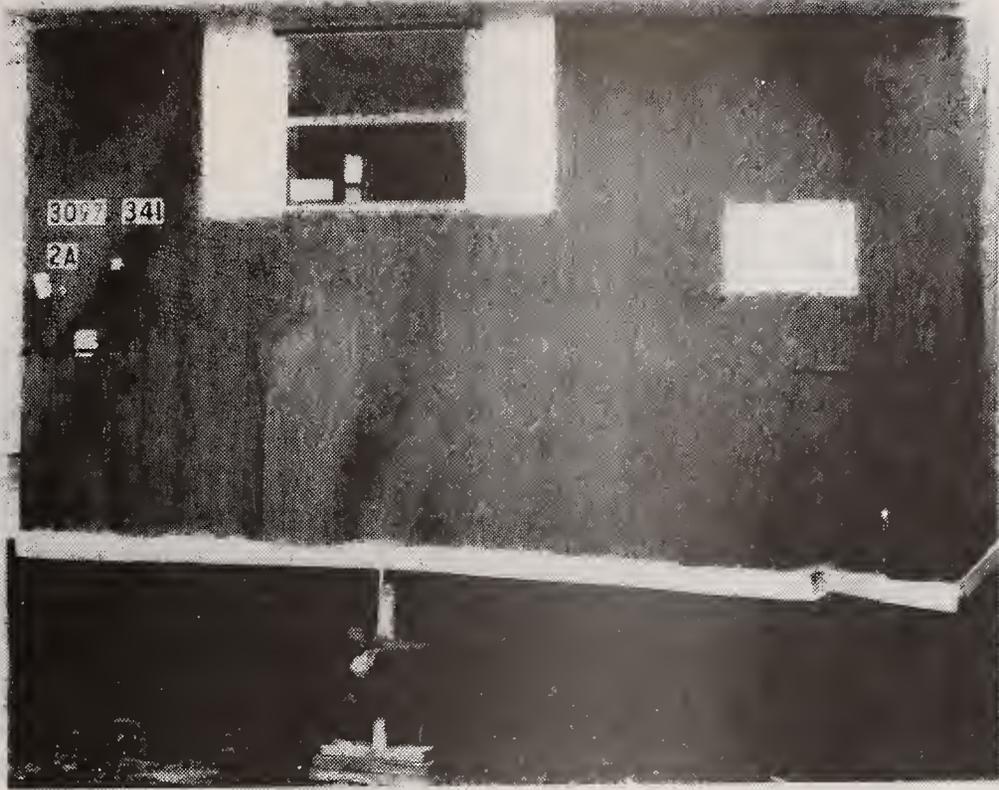
Figure 28 Transport Damage - Distorted A-Frame Assembly

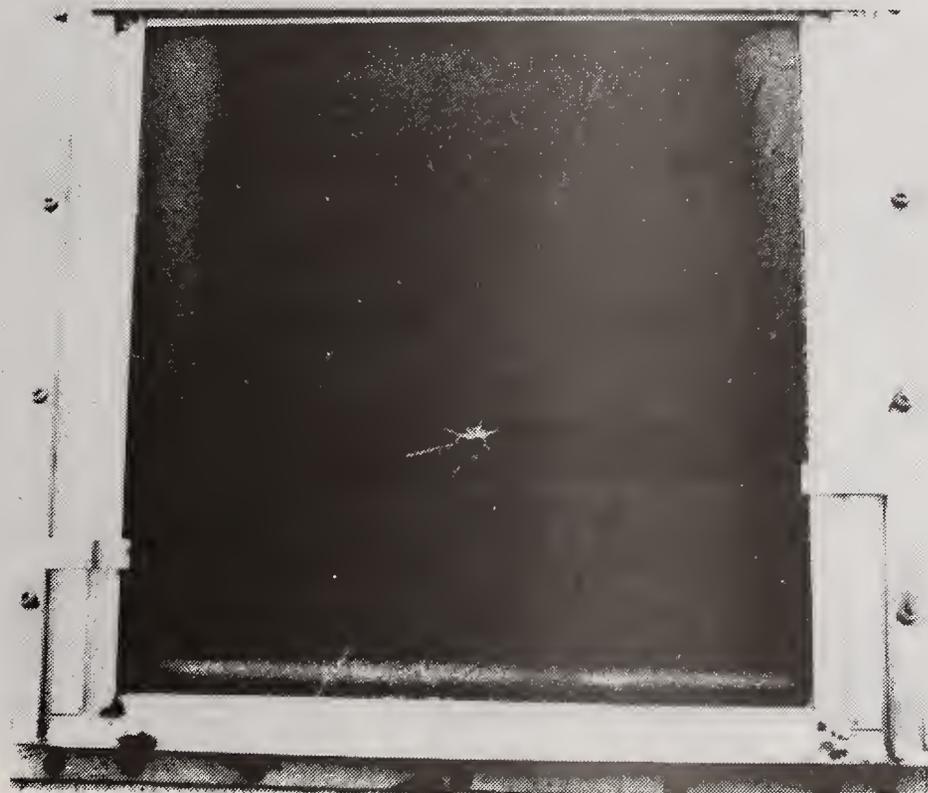
Figure 29 Transport Damage - Broken Window

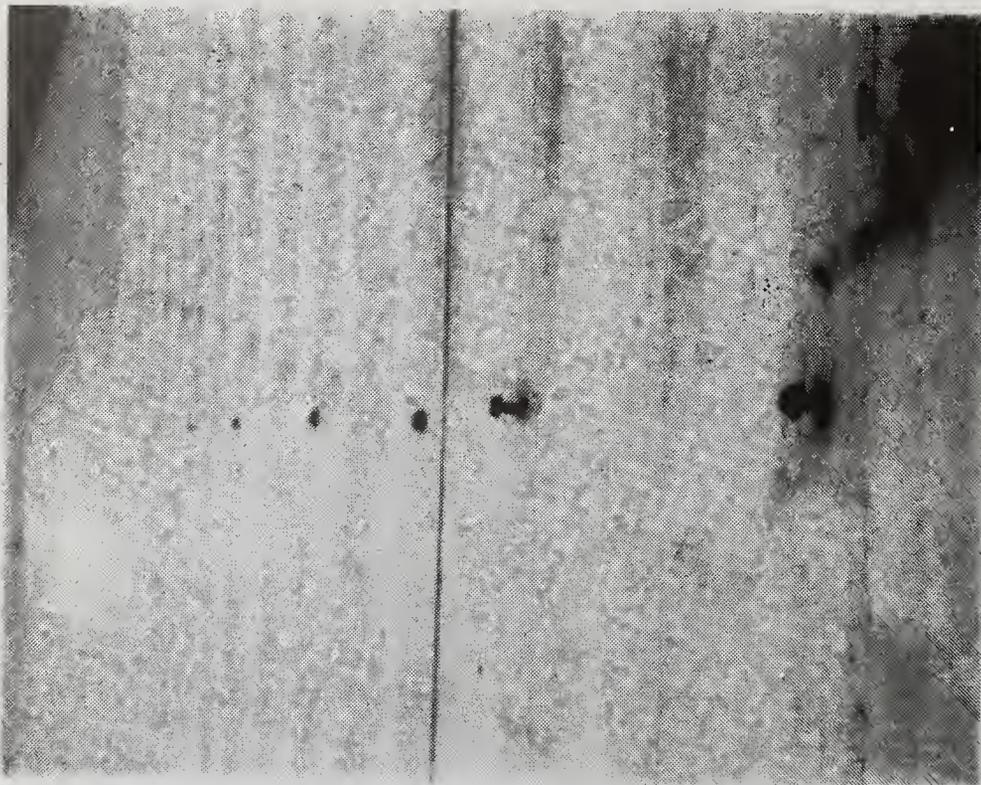
Numerous metal screw fasteners used to secure the exterior metal skin, trim, windows and doors were observed to be loose (figures 31, 32 and 33). The task of tightening loose fasteners into wood framing members is not a simple one. Pneumatic tools used to install fasteners by refurbishing crews can overtighten the fastener if not properly adjusted. Most mobile home manufacturers use similar tools during the construction process and the possibility exists that many fasteners were initially overtightened. When a fastener has been overtightened, it no longer performs its intended function and can easily become loose due to vibrations caused by transportation, wind forces, etc. Holes in the metal skin due to missing fasteners may provide an opening for the entrance of rain water.

Figure 31 Loose Fasteners - Exterior Siding

2. Metal screw fasteners used to secure the exterior metal skin, trim, windows and doors which are seen to be loose by visual inspection should be tightened. Fasteners found to be overtightened should be removed and replaced in an adjacent location so that it will perform its intended structural function. Further, the hole resulting from the removal of the fastener should be sealed with caulking or sealant material to eliminate the possibility of water entrance (figure 38). Torque adjustments should be checked periodically on all pneumatic tools to reduce the possibility of overtightening fasteners.

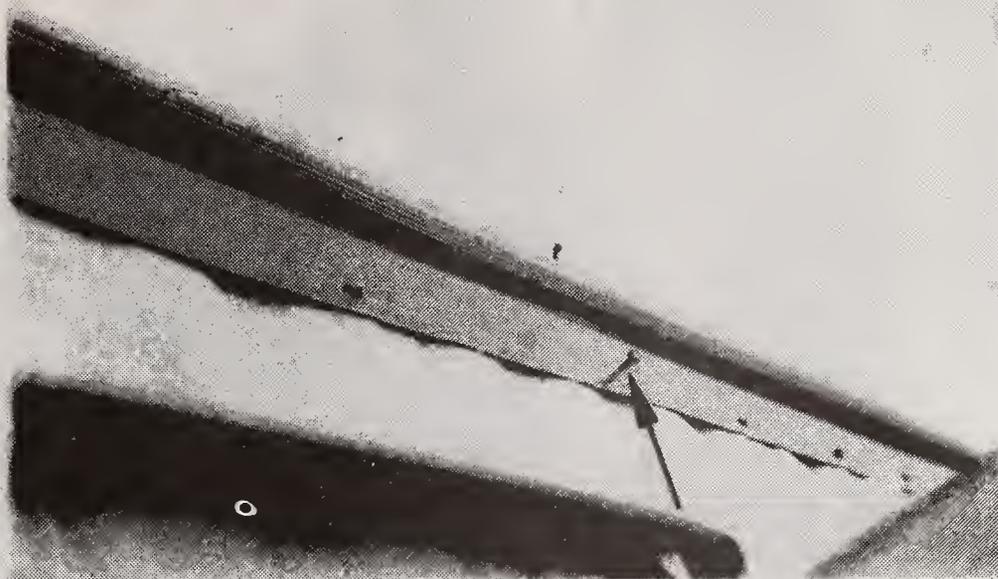
Figure 32 Loose Fasteners - Top Trim

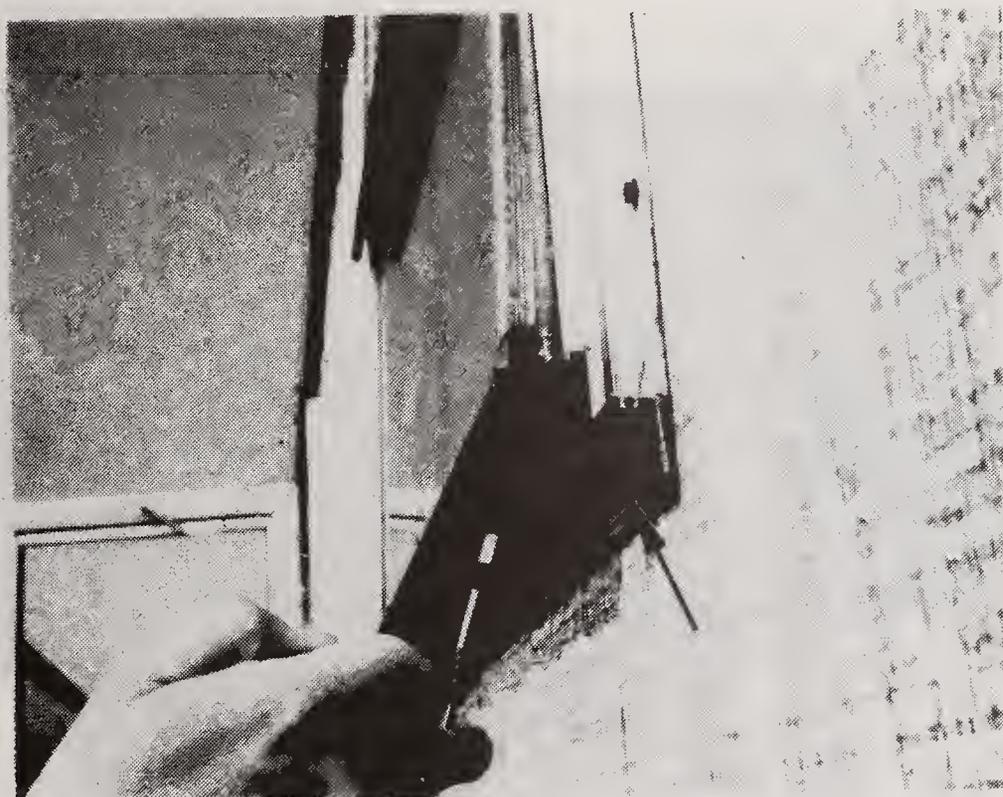
While the windows of refurbished units were generally cranked closed, the method of exterior sealing of inspected units to prevent opening during transit was not consistent. Some windows were sealed while others were not (figure 33). A variety of sealing measures were seen including the use of metal clips, plastic clips, metal strapping and duct tape (figures 34, 35 and 36). The lack of adequate window sealing could present leakage problems during transport of the mobile homes and while in storage.

Figure 33 Awning Window Which Can Not Be Tightly Closed and Loose Fastener

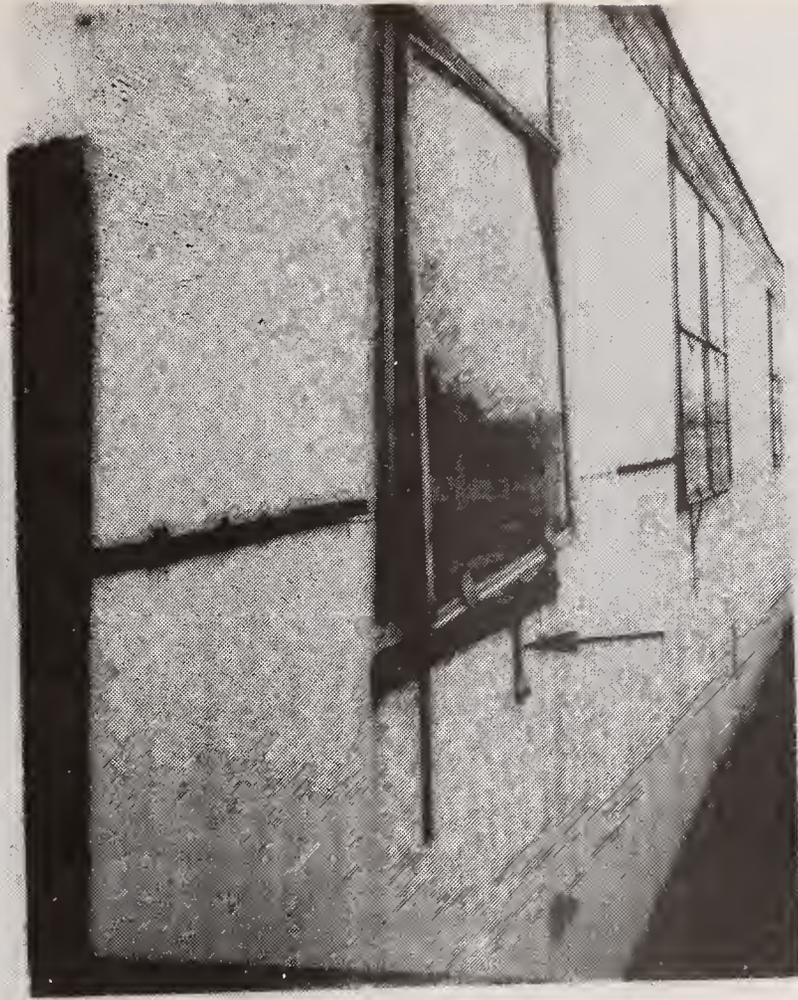
3.6.3 Inappropriate Use of Duct Tape. The use of duct tape was observed for securing awning type windows against opening (figure 36), sealing waste pipes against rodent, reptile or insect entrance (figure 41), securing cabinetry during transport of the mobile home (figure 42), and patching of damaged siding (figure 43). The long-term use of duct tape material on the exterior of a mobile home should be avoided since it will deteriorate due to weathering. Also, the tape will often damage the finish of wood cabinets when removed.

Figure 36 Duct Tape Used to Keep Awning Window Closed

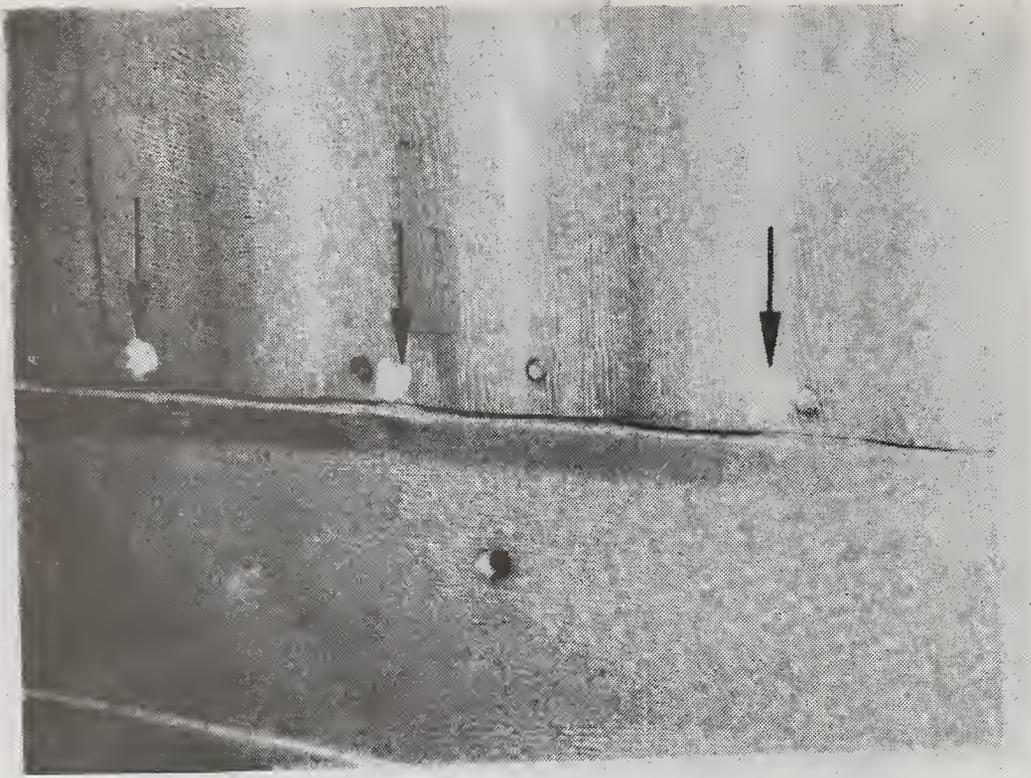
Figure 38 Small Holes in Siding Repaired With Sealant

3.6.4 Repair of Holes in Metal Skin. All small holes, splits or cracks in the metal skin should be repaired to eliminate the entrance of rain. These can be repaired by applying a metal patch with sheet metal screws along with sealant material under the patch. Small holes need only be covered with a sealant to prevent the entrance of rain (figure 38).

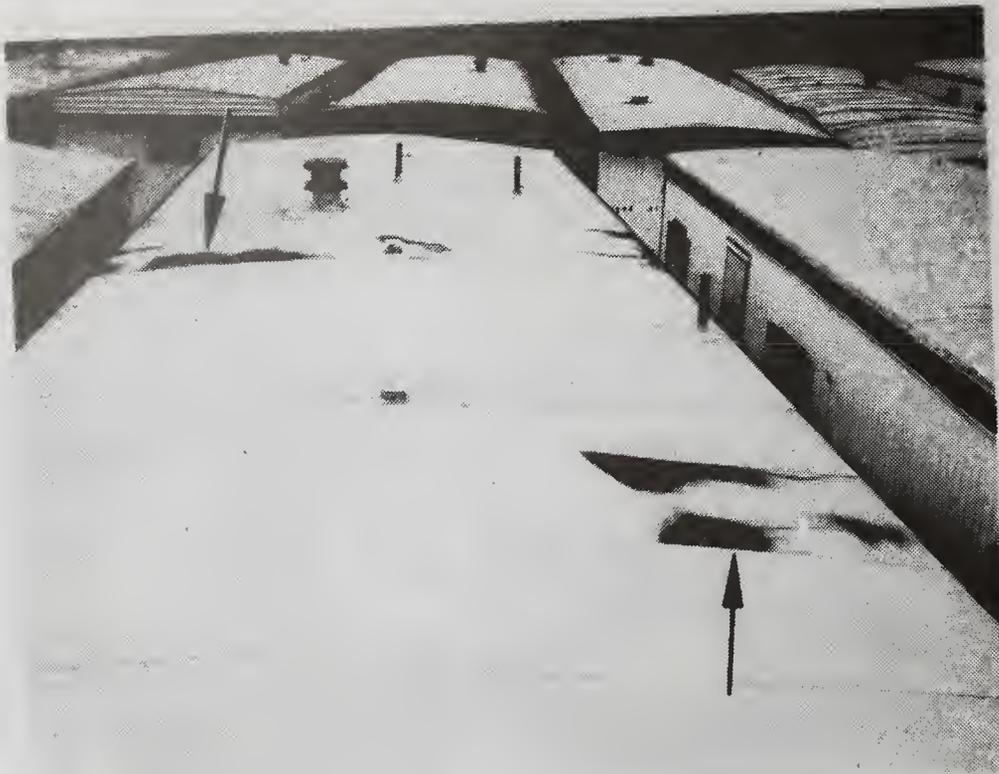
Figure 39 Rusted Metal Roof Membrane

3.6.1 Rusting Metal Roof Membrane. A small number of rusting roofs were seen during the mobile home inspections (figure 39). There is the likelihood that the corrosion process will continue until the roof rusts through. The rusted roofs should be sanded down with a fine grain emery cloth to remove the rust, followed immediately by the application of an asphalt coating material.

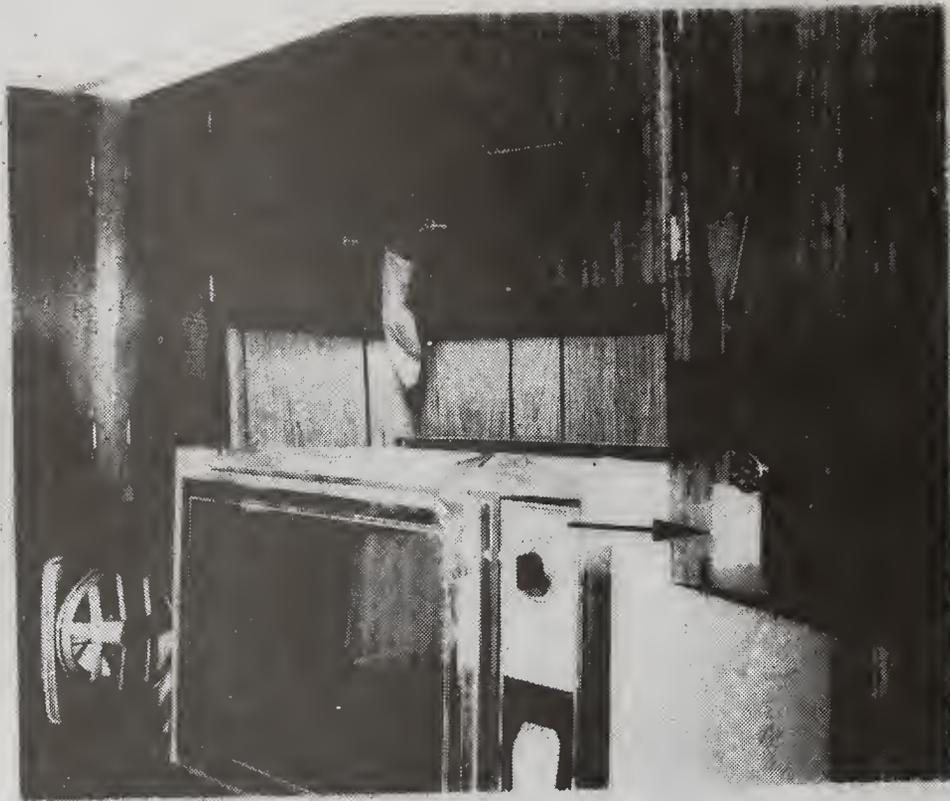
Figure 42 Attempted Repair of Finish on Kitchen Cabinets Damaged By Duct Tape Used For Support During Transport

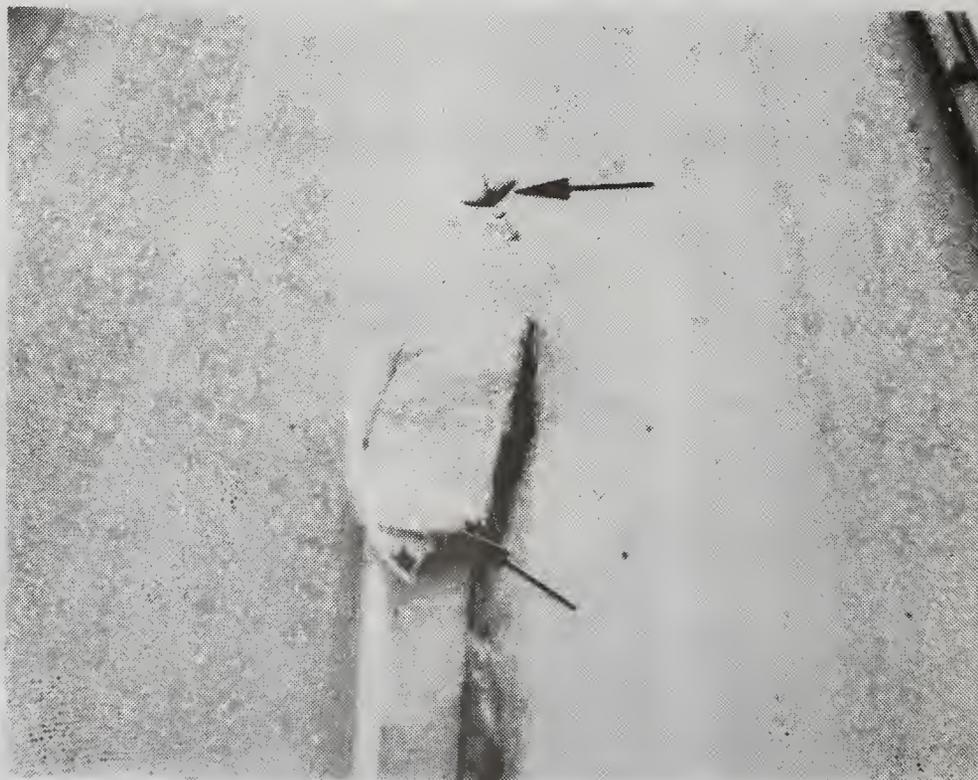
Figure 43 Weathered Duct Tape Used to Seal Hole in Siding
